Observing Goods Delivery Activities and Identifying Opportunities to Improve the Design of Commercial Vehicle Load Zones in Seattle

A thesis

submitted in partial fulfillment of the
requirements for the degree of
Master of Urban Planning
University of Washington
2018

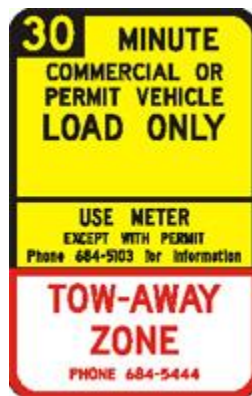
There are many competing demands for the curb. This research project focuses on one feature of curb space, commercial vehicle load zones (CVLZs). In Seattle, a commercial vehicle load zone has yellow curb paint and signage that indicates the constraints of the CVLZ. “Commercial Vehicle Load Zones (CVLZ) were established to provide, on busy streets, a special parking space for service delivery vehicles to stop. Regular truck loading and unloading zones do not adequately meet the needs of these vehicles.” (SDOT, 2018) A CVLZ requires commercial vehicles to have a paid and displayed permit in order to use it. Figure 2 is an example of CVLZ signage in Seattle.

Figure 2 City of Seattle Commercial Vehicle Load Zone Sign (Seattle Department of Transportation, 2015)

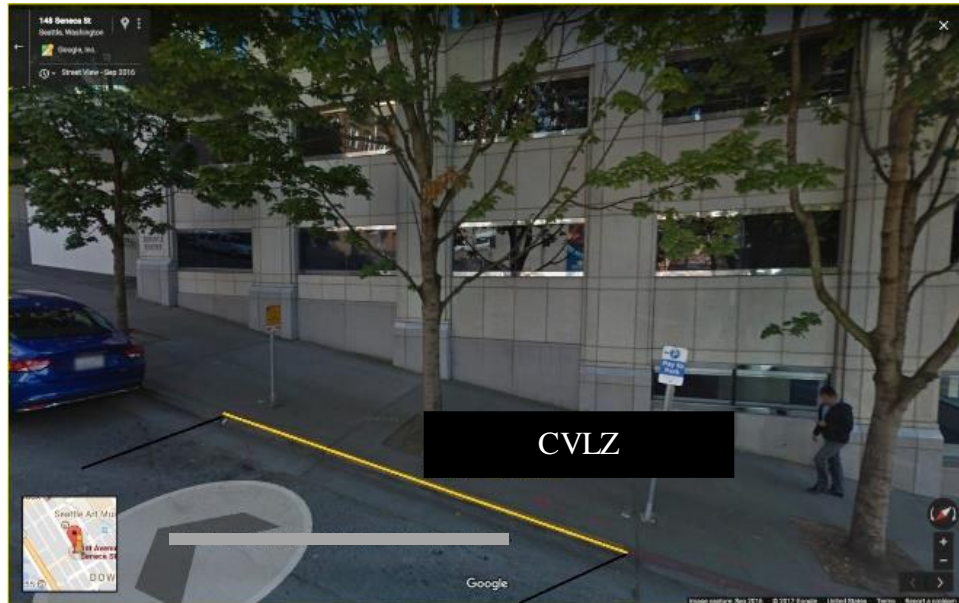
Transit Lane CVLZ without Pavement Marking

Figure 5 CVLZ Type 1 - Transit Lane without Pavement Marking (Google, 2018) (Sheth, 2017-2018)

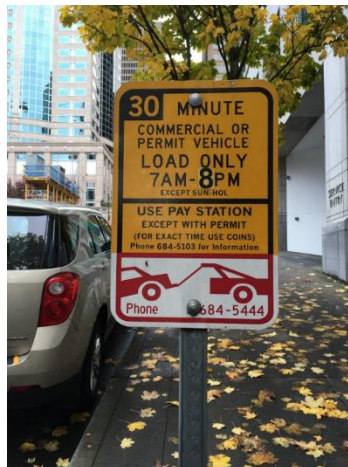
This CVLZ type is along the curb, but does not have a defined width or separation from the adjacent transit lane. In Figure 5, the width from the curb to the center line marking is about 20 feet for two lanes. (Google, 2018) The CVLZ parking lane can also be used as a transit lane before/after CVLZ hours (before 7 AM, after 8 PM). See Figure 5 for an example of this CVLZ type.

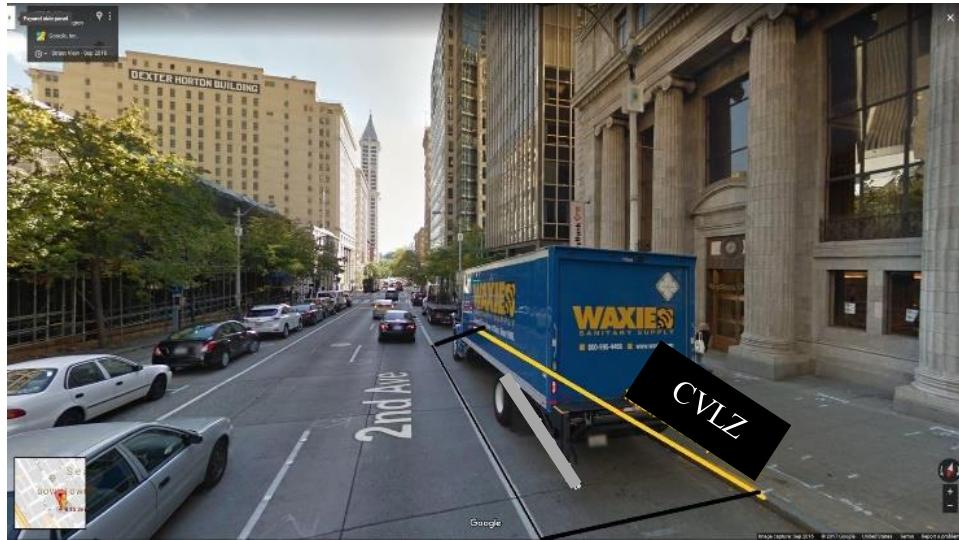
Transit Lane CVLZ with Pavement Marking

Figure 6 CVLZ Type 2 - Transit Lane with Pavement Marking (Google, 2018) (Sheth, 2017-2018)

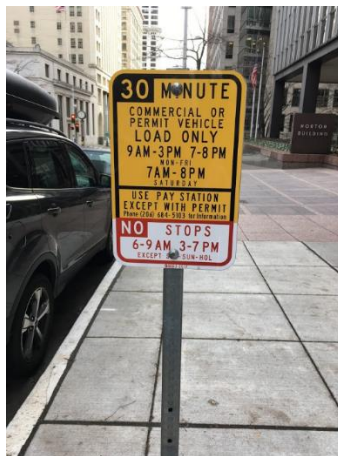
This CVLZ type is along the curb and has a solid white pavement marking that indicates the width of the CVLZ space, and clearly separates this space from the adjacent transit lane. This marking is present because the pavement marking of a white solid line and “Bus Only” pavement marking means that this CVLZ is in a Bus Only lane in Downtown Seattle. Despite this being a Bus Only lane, it accommodates curb activities like deliveries. This CVLZ is 11 feet wide. (City of Seattle, 2017) See Figure 6 for an example of this CVLZ type.

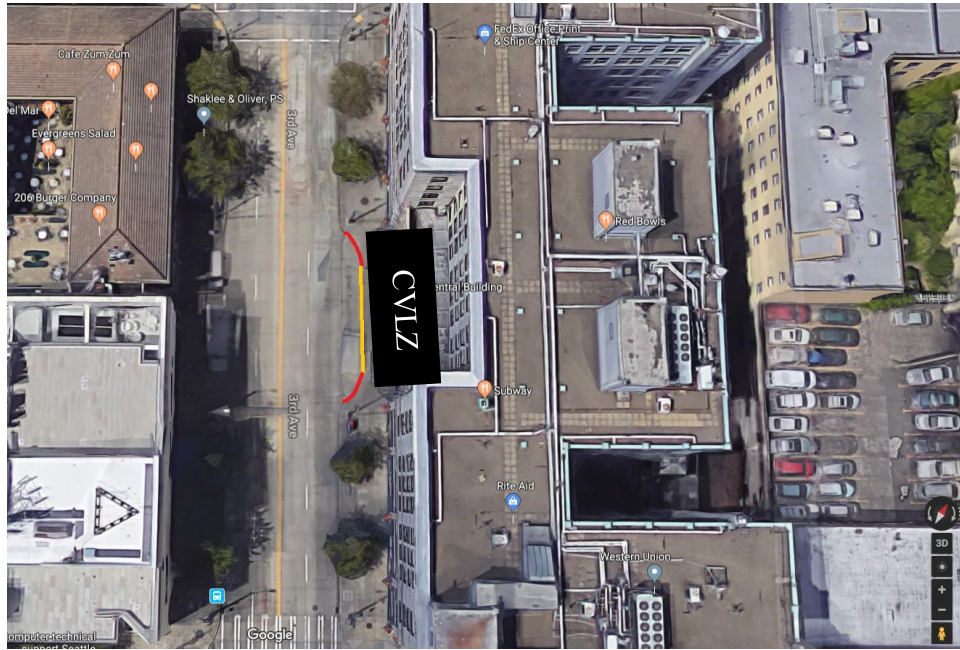
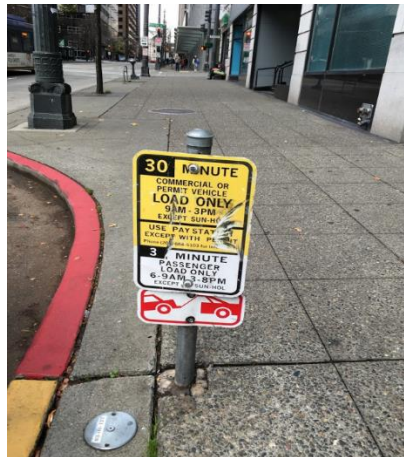
Curb Out CVLZ

Figure 7 CVLZ Type 3 - Curb Out (Google, 2018) (Sheth, 2017-2018)

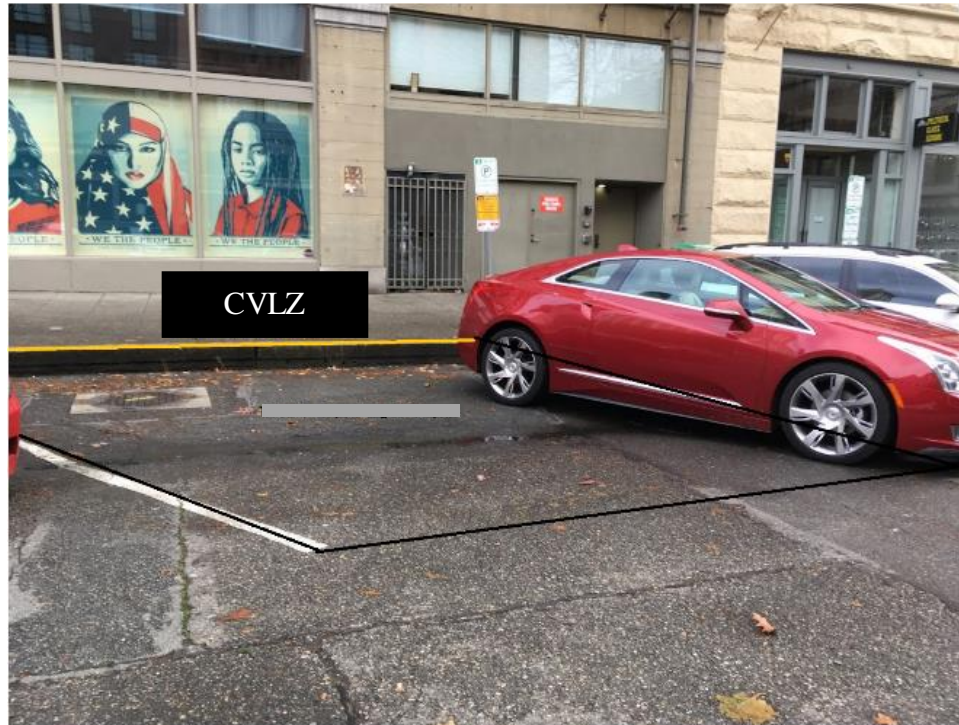
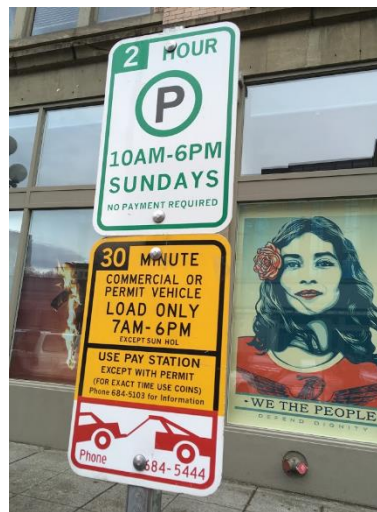
Angled Parking

Figure 8 CVLZ Type 4 - Angled Parking (Sheth, 2017-2018)

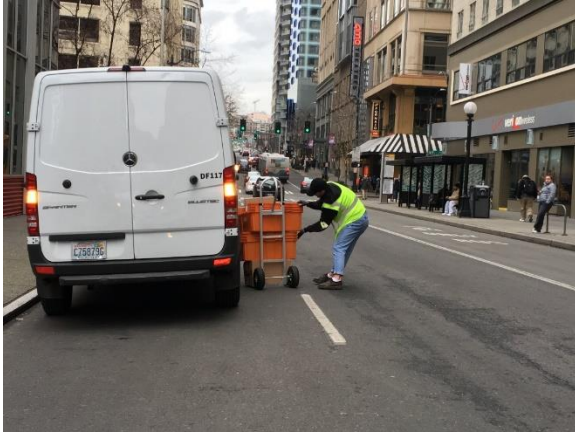
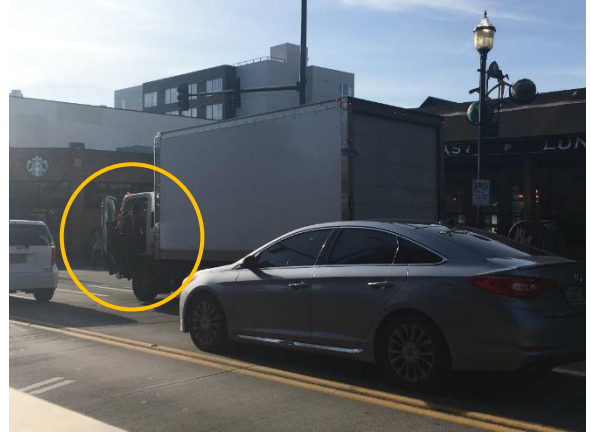
In the Vision Zero plan, there is no mention of freight/commercial vehicle safety, despite the high-risk behavior courier drivers may engage in because of insufficient freight infrastructure or poor/lack of design standards. Figure 10 exemplifies the time of high-risk behavior drivers may be involved in. Though crashes with couriers may be low in number, data does not capture the near misses. There are preemptive measures that the City could take to improve safety for couriers.

Figure 10 High Risk Courier Driver Activity in Seattle during Delivery (Sheth, 2017-2018)

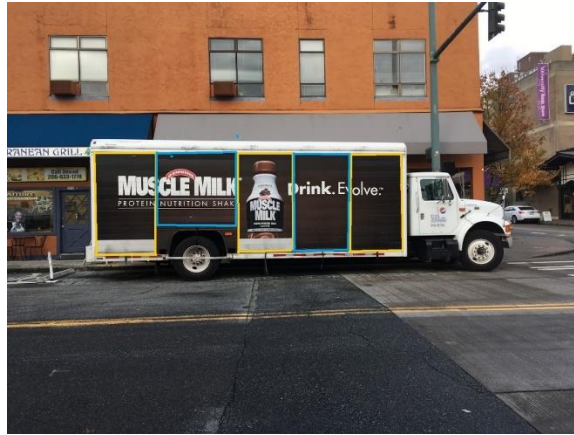
The truck had a swing out door on both the driver and passenger side of the truck. The truck design was such that it did not have any back cargo doors, but instead, had five cargo compartments on both the passenger and driver side of the truck, resulting in 10 cargo compartments. These cargo doors must be manually lifted and rolled up to retrieve goods. An image of these cargo compartments have been outlined, and can be seen in Figure 11.

Figure 11 Parked Truck at CVLZ in the U-District, Seattle. Cargo compartments outlined (Sheth, 2017-2018)

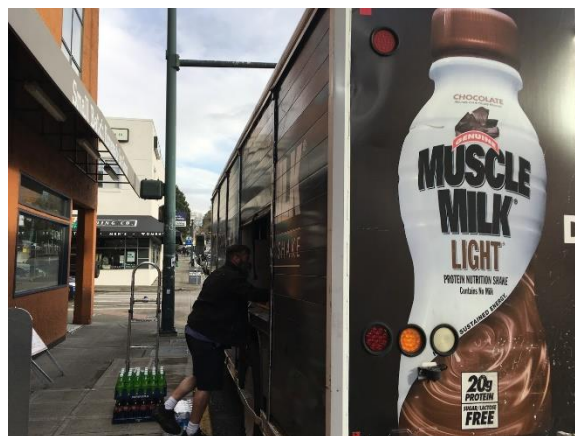
This delivery included just one driver who was also the courier, which is why the term courier driver is used. The items loaded and unloaded were invariably small pallets of Pepsi owned beverages/cans. The types of goods delivered can be seen in Figure 12.

Figure 12 Beverage Vehicle Unloading (Sheth, 2017-2018)

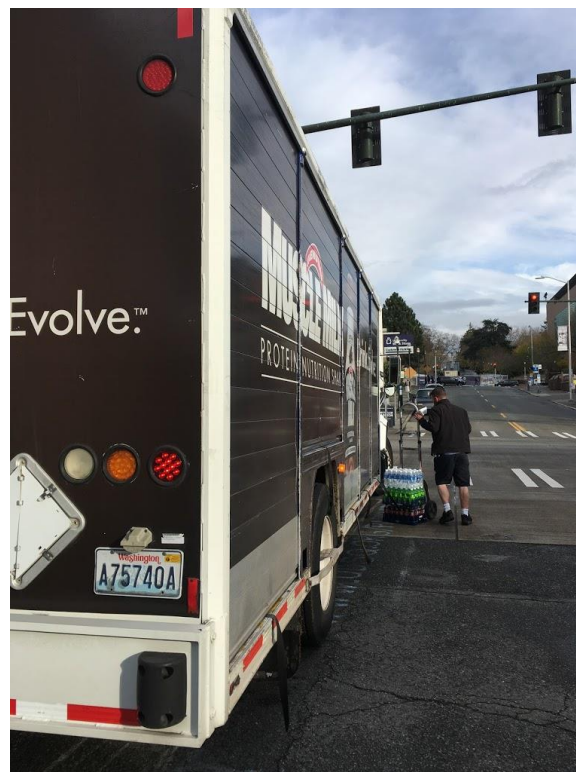
The courier mainly conducted activities while standing and taking refuge on the sidewalk. The transit lane adjacent to the delivery location was not highly utilized at the time of delivery, and so the courier did not seem to significantly restrict his while conducting loading and unloading activities on the passenger side and while standing in the roadway. Figure 13 depicts the courier's movements on the roadway.

Figure 13 Beverage Vehicle Walking Along Road (Sheth, 2017-2018)

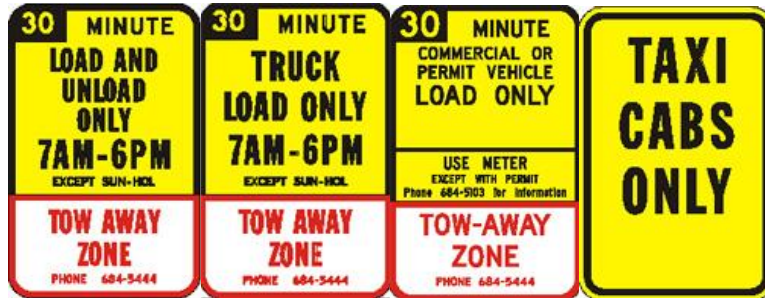
parameters for what vehicle and activity can occur at that parking spot. Depending on which sign is placed at a yellow curb, it could be permissible for a motorcycle delivering a pizza, or a large truck delivering furniture. I believe that curb space and curb color should be revisited so that the length, width, and purpose of a vehicle is paired with a color and texture/pattern, not solely matching the purpose/activity with the curb color as it is now in Seattle.

Figure 14 Seattle Yellow Curb Signage (Seattle Department of Transportation, 2018)

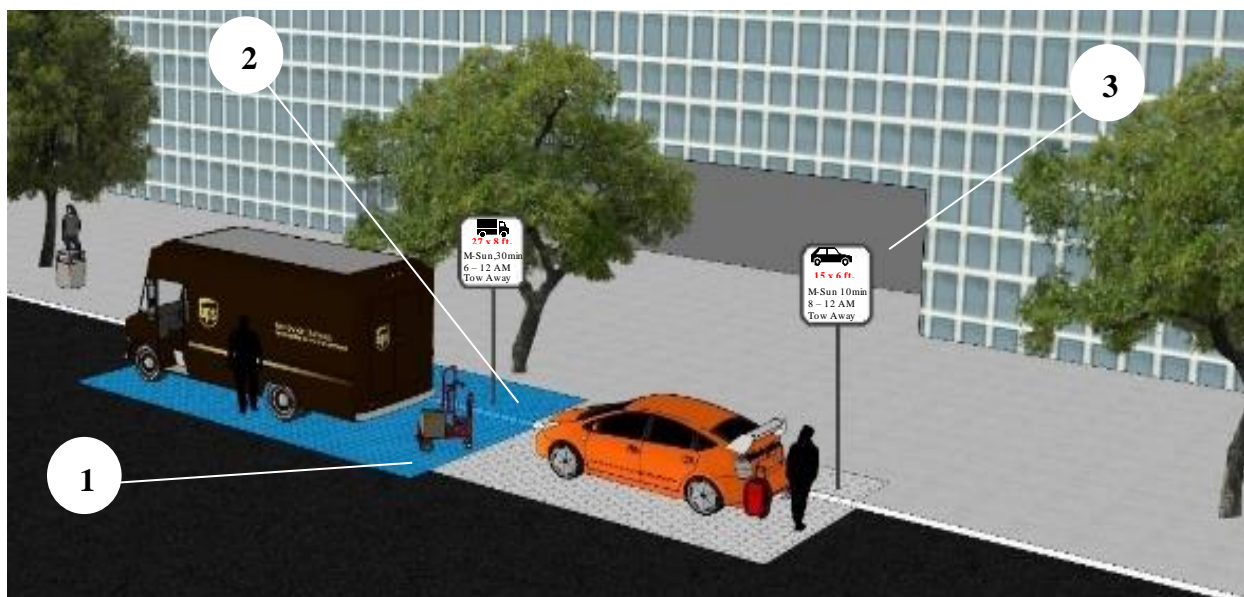
Findings from the literature review and 25 observations of deliveries in Seattle were included in the suggested redesign. This redesign can be seen in Figure 15.

Figure 15 Rendering of Curb Space Redesigned for 27x8 ft. and 15x6 ft. vehicles (Toyota, 2018) UPS Truck Dimensions courtesy of Anna Alligood and Siqi Lu

- 2) Provide space around the vehicle so that vehicle features such as doors can fully engage, and accessories can be comfortably used as needed. As seen in the major takeaways from the field observations, most deliveries included using a hand truck as an accessory and most of the observed vehicles had a cargo compartment located at the back end of the vehicle. The design of the blue curb space in Figure 82 not only respond to these needs, but exceeds them by providing additional space on the sidewalk and driver's side for additional activities. It may also support the needs of a beverage truck seen in Figure 13 and a pick-up system in which high density office/residential buildings provide a staff member to meet the courier at the curb with a bin to consolidate and retrieve deliveries.

It is important that the three recommendations be implemented as a trio because they each complement each other and are integral for optimizing the efficacy of the freight curb design. The paint and texturing indicate to curb users the minimum and maximum length and width of that particular curb parking space. The paint and texturing on the curb indicates the minimum/maximum amount of space that may be needed for the activities occurring at the curb parking space. The signage clearly communicates the limitations and regulations of the curb parking space. These three items together serve as a holistic system.

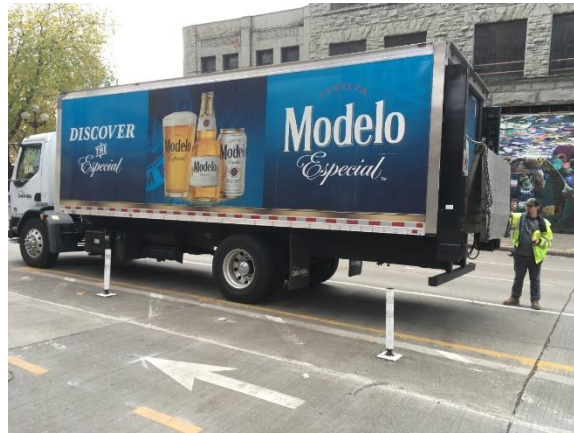
Figures 17 and 18 exemplify the truck characteristics of the observed delivery.

Figure 17 Lift Gate Operations (Sheth, 2017-2018)

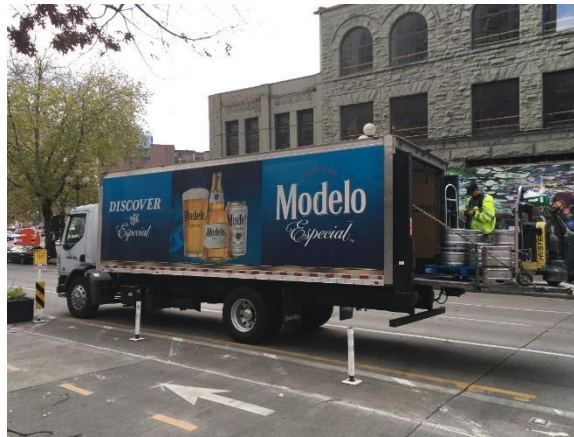
Figure 18 Lift Gate Engaged (Sheth, 2017-2018)

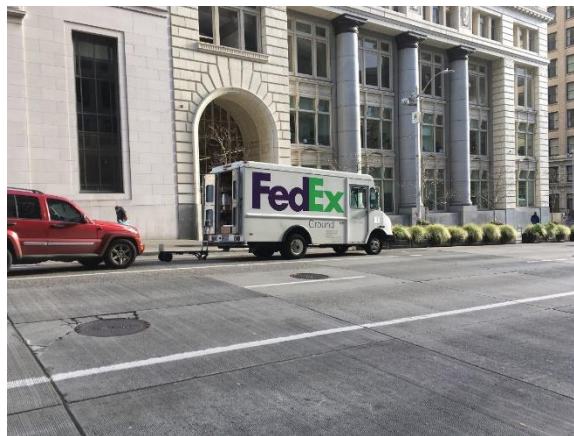
The driver and passenger door is a sliding door, and was open and shut upon entry and egress of the truck. The truck design included cargo compartments at the back end of the truck with two doors that opened out.

Figure 19 FedEx Delivery Hand Truck Space (Sheth, 2017-2018)

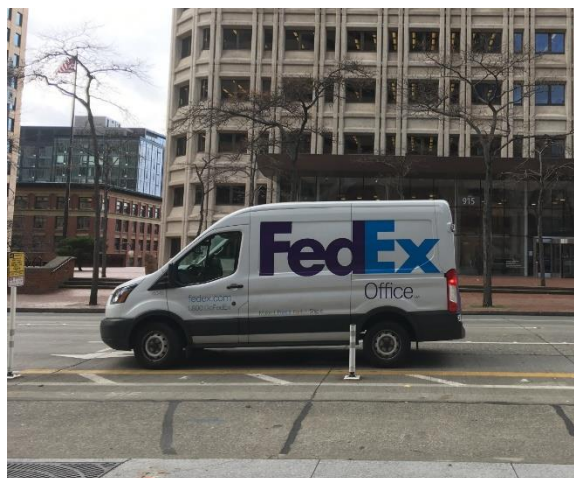
The observed delivery vehicle was a FedEx Office vehicle. This is a Class 3 vehicle that resembles a van more than it resembles a truck, and can be seen in Figure 20.

Figure 20 FedEx Office Van Delivery Vehicle

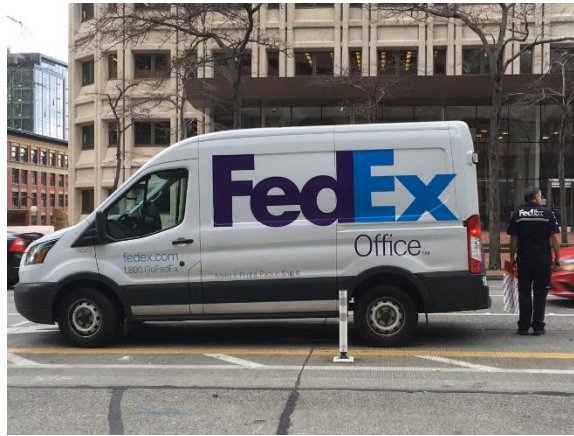
The courier driver exited from the driver side and cut through the bike buffer lane and bike lanes adjacent to the driver side to quickly access the sidewalk. He eventually returned from his customer with a small parcel, cut through the bike lanes and bike buffer lane and stood behind the back-end of the truck and waited for flowing traffic in the transit lane next to the passenger side to subside. Figure 21 depicts the courier in the act of waiting at the back end of his vehicle with his customer's parcel for the traffic in the transit lane to subside.

Figure 21 Courier of observed delivery waiting for traffic in adjacent transit lane to subside (Sheth, 2017-2018)

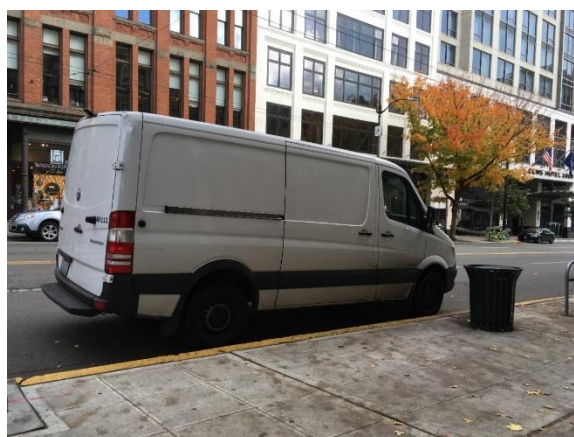
The driver and front passenger doors are both swing out doors. There were two doors on the passenger side of the vehicle, the first one in front was swing out, and the second was with a sliding door. There was also a cargo compartment at the back end of the vehicle with two doors that open out.

Figure 22 Observed Amazon Commercial Vehicle (Sheth, 2017-2018)

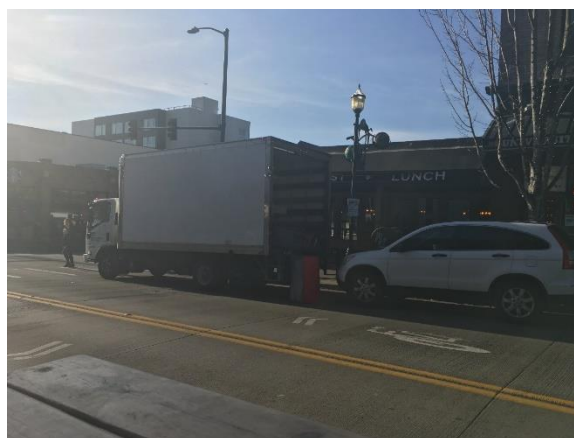
Figure 23 depicts the observed delivery vehicle. This vehicle has two side doors, one for the driver and passenger respectively. The door types are swing out doors. The cargo compartment is located in the back end of the truck, and has a manual roll up cargo door.

Figure 23 Observed Amazon Delivery Truck (Sheth, 2017-2018)

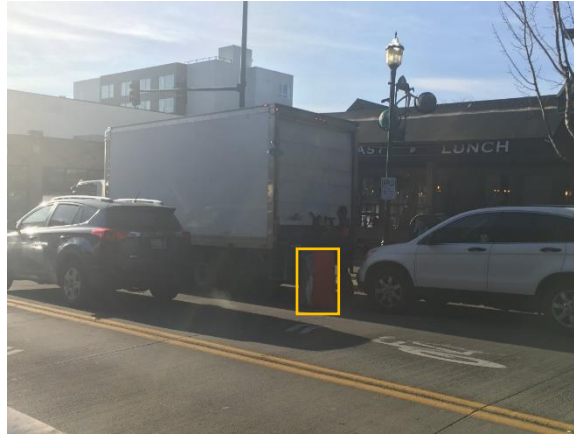
assembly or disassembly required. The hamper simply sprung into shape. The hamper stayed behind the vehicle while the courier driver stepped into the cargo compartment and organized parcels and placed them into the hamper from the inside of the cargo compartment.

Figure 24 Hamper (Accessory Used) Outlined in Yellow (Sheth, 2017-2018)

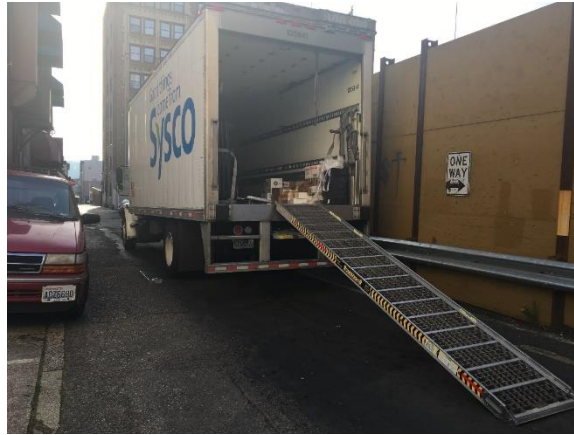
A Sysco refrigerated delivery vehicle was observed during this delivery. This is a Class 5 vehicle. Figure 25 depicts the observed commercial vehicle. The driver and passenger doors are swing out doors. The cargo compartment has a roll up door.

Figure 25 Observed Sysco Vehicle, Ramp Engaged (Sheth, 2017-2018)

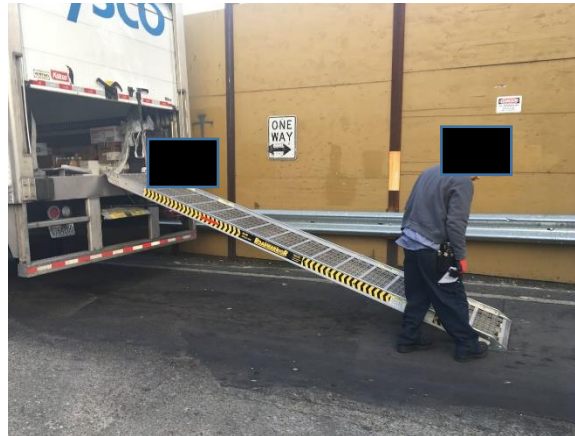
Multiple deliveries were made to the same customer using the hand truck and ramp. At end of the deliveries, the hand truck was placed back inside the cargo compartment and the ramp was collapsed back into its compartment.

Figure 26 Courier Completes Extending Ramp and its Placement (Sheth, 2017-2018)

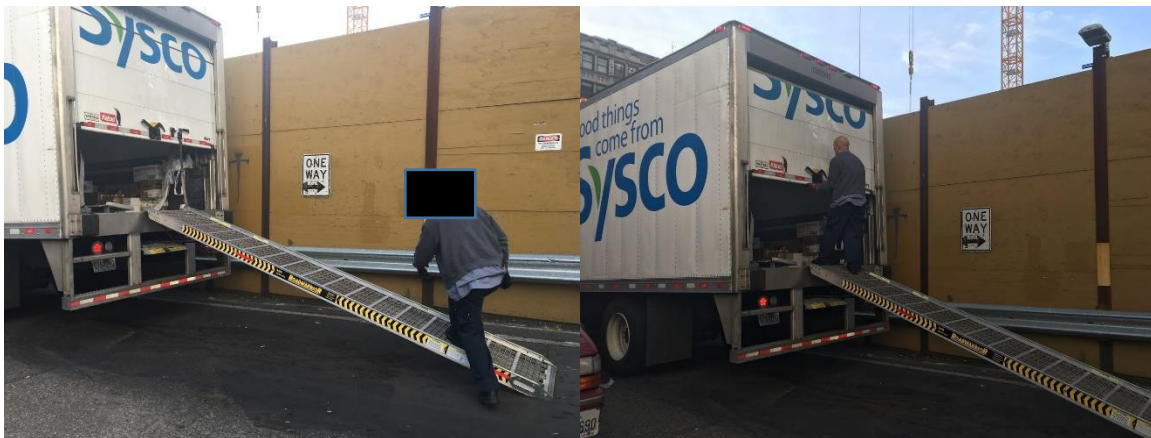
The courier driver used a ramp and a hand truck for this delivery. To extend the ramp, the courier driver first lifted up the cargo compartment door slightly in order to access the ramp extension. He then stood on to one side of the ramp and pulled the ramp out of its compartment, while walking backwards next to it. The courier's stance in relation to the ramp is exemplified in Figure 26. After extending the ramp, he walked up the newly extended ramp, and completely rolled up the cargo compartment door. These movements can be seen in Figure 27.

Figure 27 Courier Fully Rolling Up and Lifting Cargo Compartment (Sheth, 2017-2018)

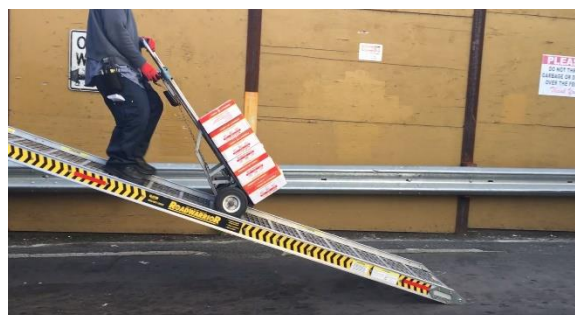
A hand truck was also used for this delivery. The hand truck was stored in the cargo compartment, and was then rolled down the ramp and around to the customer. Please see Figure 28 for an image of the hand truck being rolled down the ramp.

Figure 28 Courier Using Ramp to Deliver Goods using the Ramp and Hand Truck (Sheth, 2017-2018)

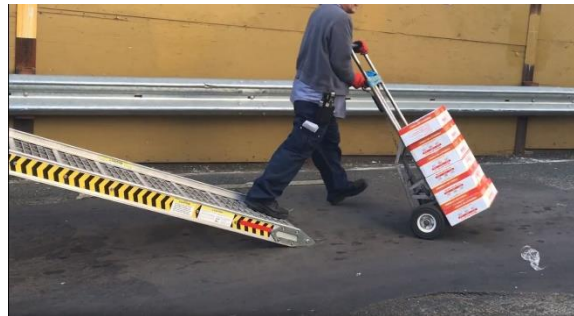
After organizing the goods and loading the hand truck, he walks it down the ramp. When exiting the ramp with the hand truck, additional space required to turn the hand truck is noted. The additional space required after the ramp has been extended is depicted in Figure 29.

Figure 29 Additional Space Required to Maneuver Hand Truck (Sheth, 2017-2018)

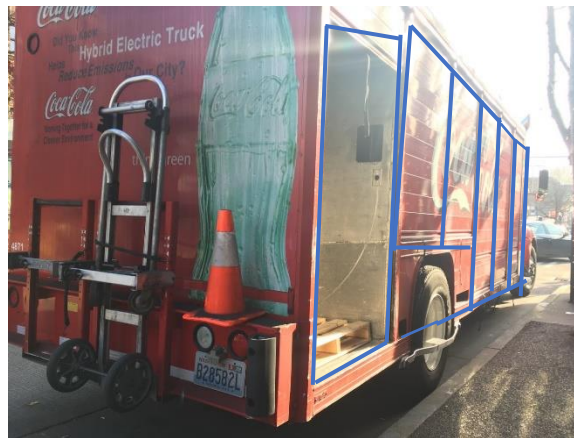
It has six cargo compartments on the driver and passenger side of the vehicle each. Figure 30 exemplifies the location of the cargo compartments, which have been outlined blue, and design of the vehicle. Each of the cargo compartments are roll up cargo doors.

Figure 30 Coca Cola Delivery Vehicle (Sheth, 2017-2018)

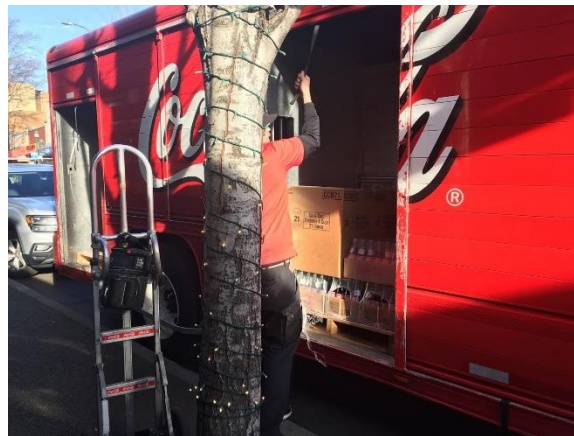
The courier driver was not fully observed when he first accessed the cargo. To unload and load the hand truck and beverage crates, the courier driver stood on the sidewalk while comfortably accessing the cargo. His stance did not block pedestrians, and can be seen in Figure 31.

Figure 31 Courier Driver Accessing Cargo Compartments (Sheth, 2017-2018)

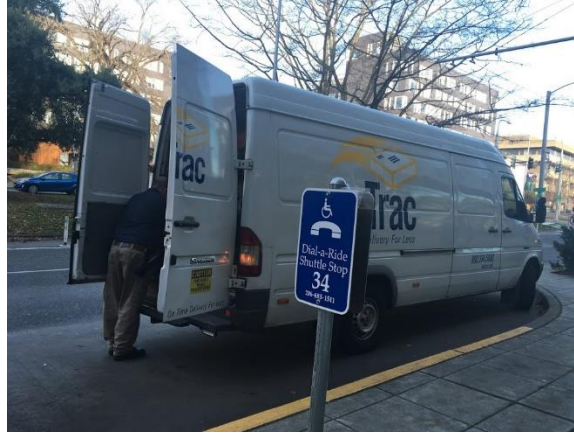
The observed vehicle is an OnTrac delivery van. This is a Class 3 vehicle. This commercial vehicle has swing out driver, passenger, and cargo doors. It is unclear if the passenger door on the passenger is a sliding door or a swing out door, and could not be confirmed because it was not used during the delivery. The cargo compartment that was used was on the back end of the vehicle, and had two swing out cargo doors. Please see Figure 32 for a visual aid for this observed delivery.

Figure 32 OnTrac Observed Delivery Vehicle with Extended Cargo Doors (Sheth, 2017-2018)

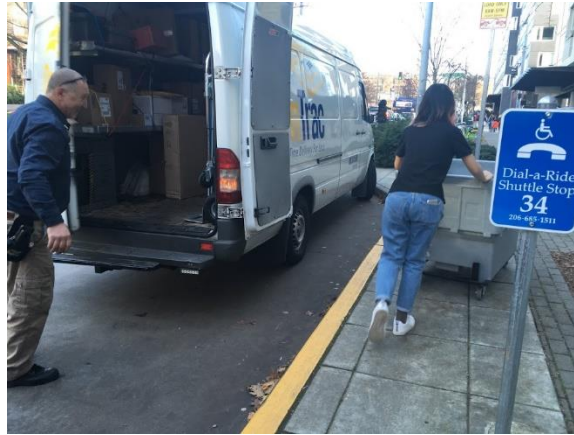
A large bin on wheels was used for this delivery. It is interesting to note that the bin was provided by the high density building that was receiving the parcels. In this case, this building is a dorm (Lander Hall) at the University of Washington. The bin was rolled onto the sidewalk from the building and stayed on the curb while it was loaded with parcels. The bin was then rolled back to the building on that same block. The building was adjacent to the parked delivery vehicle, and therefore, no crosswalks were utilized or roads crossed. Figure 33 exemplifies the bin used for this delivery.

Figure 33 Accessory for this Delivery - Bin on Wheels (Sheth, 2017-2018)

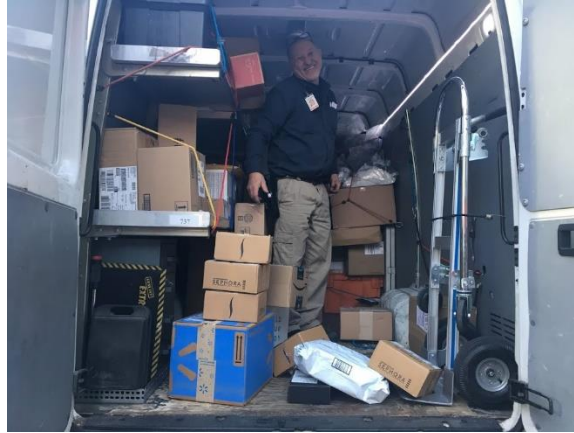
This delivery included one driver who was also the courier. The items delivered were parcels of all sizes. Figure 34 exemplifies the size of parcels the driver/courier was organizing and delivering.

Figure 34 Parcels Being Organized and Scanned Within the Cargo Compartment (Sheth, 2017-2018)

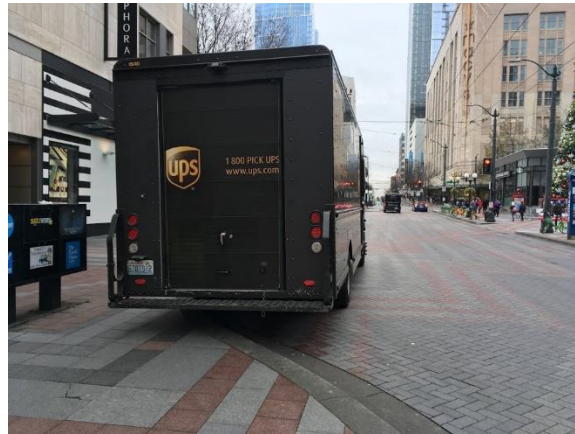
This vehicle type has sliding driver and passenger doors and a roll up cargo compartment at the back end of the vehicle. Figure 35 exemplifies the cargo compartment location and type.

Figure 35 Observed UPS Vehicle - Cargo Compartment at Back End (Sheth, 2017-2018)

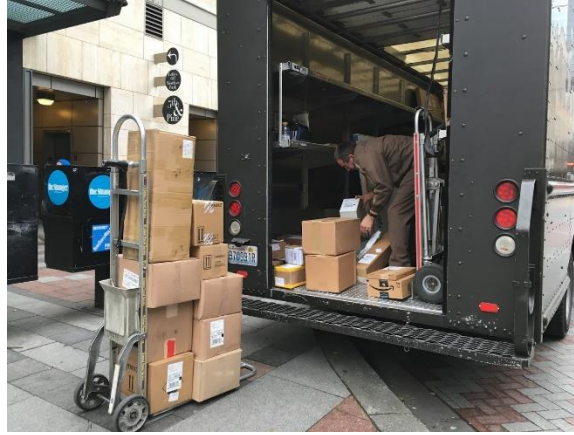
During the observed delivery, the hand trucks were kept on the sidewalk they were already on to complete the deliveries. Depending on the needs of that particular round of deliveries, the courier driver would pick one of them that best suited his needs, and placed the other one back.

Figure 36 2-Way Convertible Hand rucks Used in Delivery (Sheth, 2017-2018)

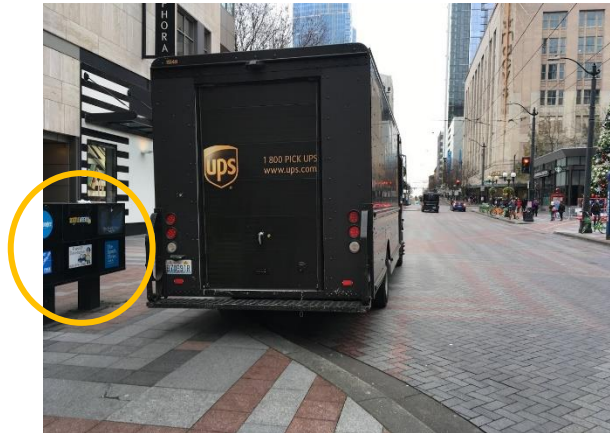
The curb-cut design of the passenger load/unload zone also facilitates a type of bulb-out of the sidewalk. This bulb-out was observed to be very convenient for the driver/courier, because when he operated behind the vehicle, he was simply standing on the bulb-out portion of the sidewalk. There were newspaper stands on the sidewalk adjacent to the delivery vehicle. Though this was not significantly obstructive, it was noted to be quite close to the vehicle as seen in Figure 37.

Figure 37 Newspaper Stand Adjacent to Observed Delivery Vehicle (Sheth, 2017-2018)

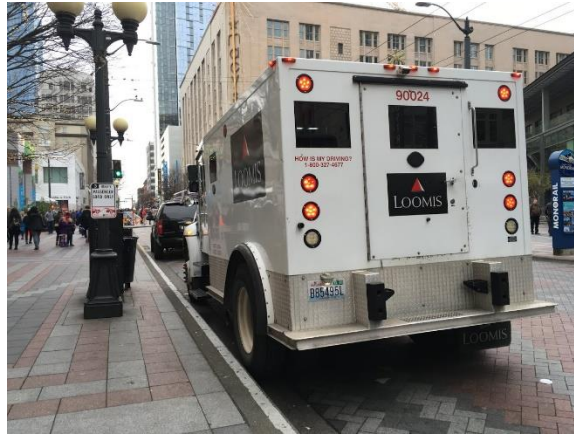
The observed vehicle was a LOOMIS vehicle. This is a Class 5 vehicle. The driver and passenger vehicle are swing out doors. The cargo compartment was located at the back end of the vehicle and was also a swing out cargo door. Figure 38 exemplifies the design of the observed delivery vehicle.

Figure 38 Observed LOOMIS Delivery Vehicle (Sheth, 2017-2018)

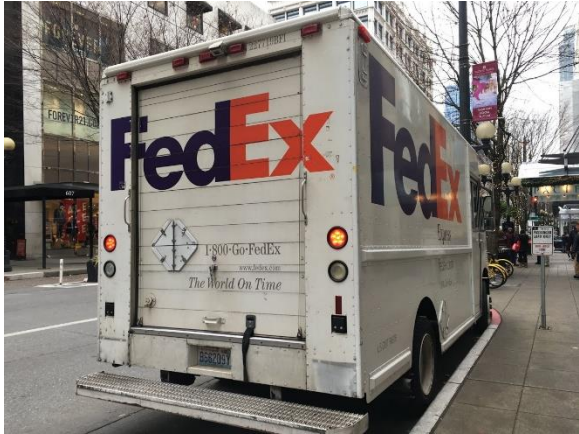
The observed vehicle is a FedEx delivery truck. This is a Class 5 vehicle. This vehicle has sliding driver and passenger doors. The cargo compartment is located at the back end of the vehicle and has a roll up cargo door. Figure 39 exemplifies the observed vehicle and its design features.

Figure 39 Observed FedEx Delivery Vehicle (Sheth, 2017-2018)

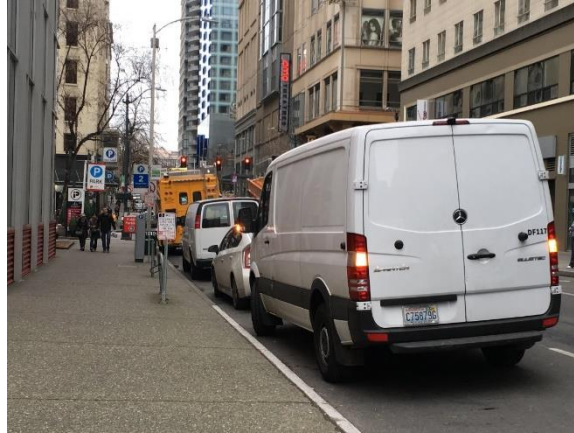
This vehicle was deployed to make a delivery, but the company affiliation is not clear. This is a Class 3 vehicle. The driver and passenger doors are swing out. The cargo compartment is located at the back end of the vehicle and has two open out doors. The second door on the passenger side is a sliding door.

Figure 40 Observed Vehicle (Sheth, 2017-2018)

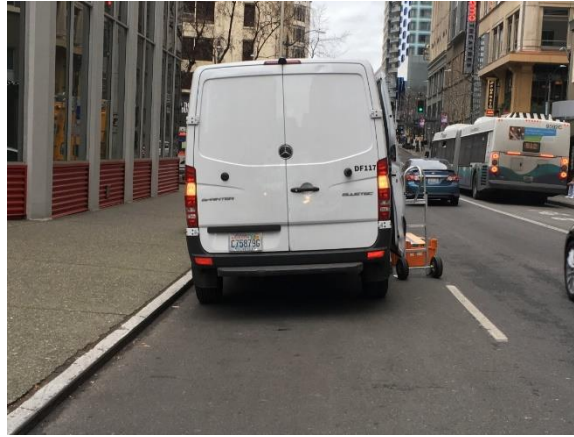
A hand truck and bins were used in this delivery. These accessories were stored in the second passenger compartment. These accessories were pulled out and placed onto the road space adjacent to the second passenger door. The placement of these accessories can be seen in Figure 41. The bins and goods were loaded on to the hand truck on the roadway and then pull around next to the back end of the vehicle and onto the sidewalk.

Figure 41 Accessories Used and Placement (Sheth, 2017-2018)

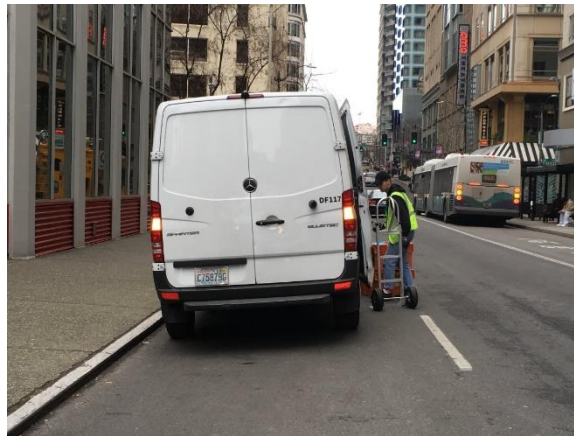
The courier driver had exited from the driver side of the vehicle onto the sidewalk. He then walked around the back end of the vehicle over to the second passenger door. He stood next to the second passenger cargo compartment, and at times, strayed into the adjacent transit lane. Figure 42 displays some of his movements next to the passenger cargo compartment. After loading the hand truck with a large parcel and two bins, he walks around the back end of the vehicle with the hand truck and onto the sidewalk. His return to the vehicle was not captured.

Figure 42 Driver/Courier Observed in Adjacent Transit Lane (Sheth, 2017-2018)

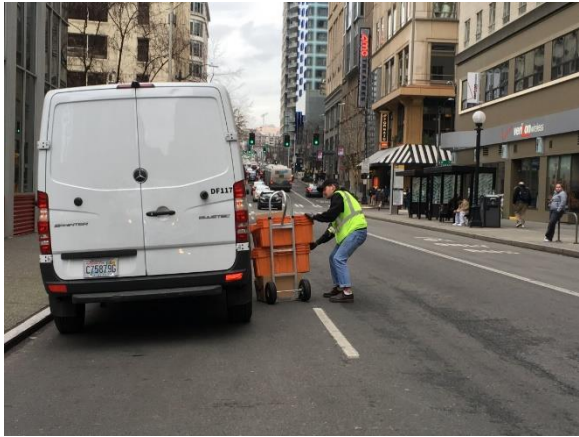
This delivery took place in Downtown Seattle next to the Westlake Station. This area is mix of commercial and office space. The courier driver chose to park at a 3-minute passenger load/unload zone. Though he was parked for at least 20 minutes. This is a one way, three lane street. One lane is mainly allocated to parking, the second is a transit lane, and the third is a bus only and bike lane. The courier driver was observed using a substantial amount of space in the adjacent transit lane while loading the hand truck. This is generally a highly congested area and the courier driver’s actions are high risk. Figure 43 exemplifies the extent to which the courier operated in the adjacent transit lane.

Figure 43 Courier Operating in Adjacent Transit Lane (Sheth, 2017-2018)

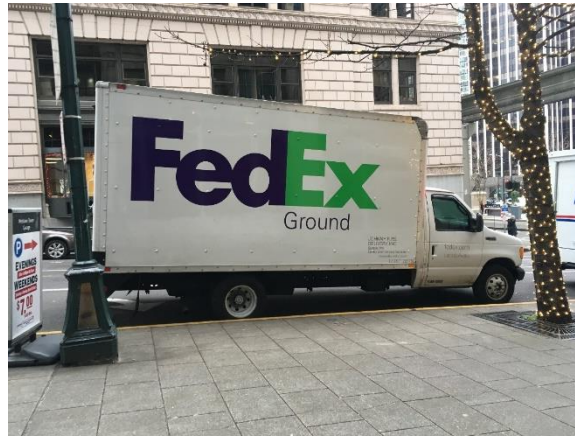
The driver and passenger doors are open out doors. The cargo compartment is located at the back end of the vehicle, and has a roll up cargo compartment. Figure 44 exemplifies the design of the observed vehicle.

Figure 44 Observed FedEx Ground Vehicle (Sheth, 2017-2018)

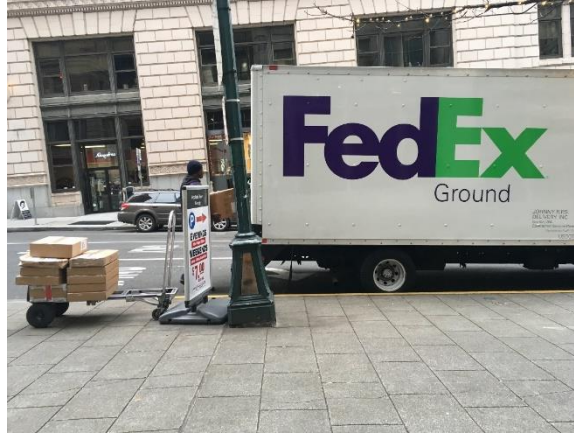
The accessory used in this delivery is a 2-way convertible hand truck. During the observed delivery, the courier driver was managing returns. He had walked along the sidewalk and placed the hand truck next to the cargo compartment on the sidewalk. The courier driver would stand on the road behind the cargo compartment and kept the hand truck on the sidewalk. The placement of the hand truck in relation to the cargo compartment and courier driver can be seen in Figure 45.

Figure 45 2-Way Convertible Hand Truck Placed and Accessed on Sidewalk (Sheth, 2017-2018)

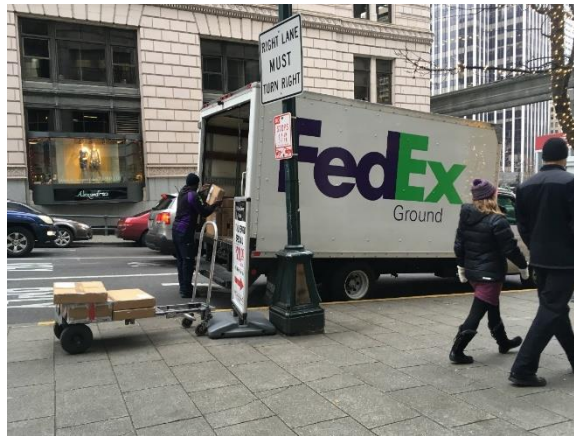
At the time of the observed delivery, the courier driver was observed transporting parcels to and from the cargo compartment using the hand truck. He stood behind the cargo compartment on the road in order to access and manage the parcels. The 2-way convertible hand truck stayed on the sidewalk next to the cargo compartment. The courier driver can be seen managing his parcels in Figure 46. During the time of observation, two delivery sessions were completed by the one courier driver.

Figure 46 Courier Driver Managing Parcels (Sheth, 2017-2018)

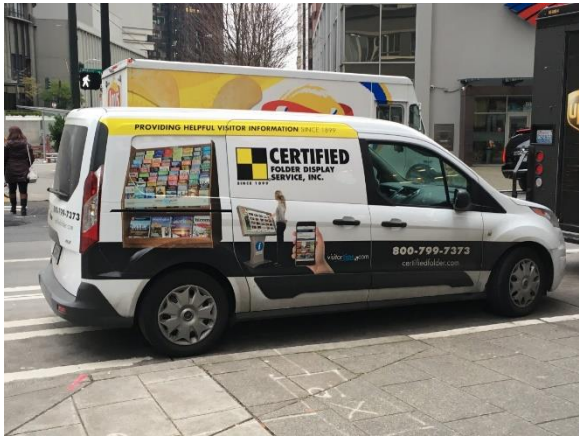
The observed vehicle is a Certified Folder Display Service, Inc. delivery van. This is a Class 3 vehicle. The driver and passenger doors are open out doors. The second passenger door is a slide open door. The trunk of the vehicle has a lift up door. The second passenger door and trunk both serve as the cargo compartment. Figure 47 exemplifies the vehicle type and design.

Figure 47 Observed Delivery Vehicle (Sheth, 2017-2018)

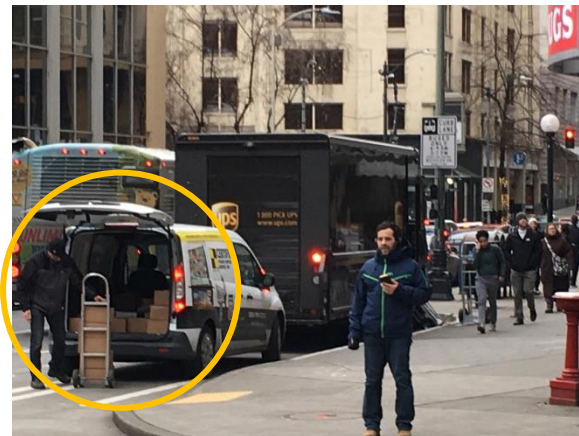
A hand truck was used in this delivery. This hand truck was stored in the back end of the cargo compartment, taken out, assembled on the street, and loaded. During the observation, the hand truck was loaded on the street and then taken up the curb ramp seen in Figure 48. The courier driver loaded the hand truck, made a delivery, returned to the same location to reload the hand truck, and made another delivery following the same path.

Figure 48 Hand Truck Observed in Delivery and Cross Walk (Sheth, 2017-2018)

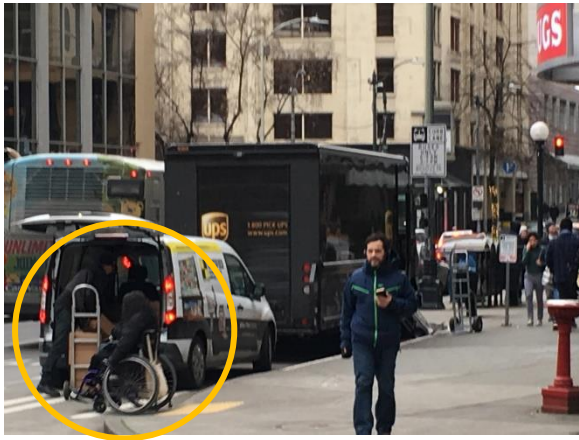
This delivery took place in Downtown Seattle, in an area with high density commercial and office space. The courier driver chose to park at an unmarked curb, behind a 3-minute passenger load/unload zone. The back wheels of the vehicle is very close to the crosswalk marking, and the back bumper is in fact hovering of a part of the crosswalk. This can be clearly seen in Figure 49. The delivery load/unload process occurred on the crosswalk, though it did not significantly impact pedestrian movement. Figure 49 captures a moment in which someone in a wheelchair utilized the crosswalk while the hand truck was being loaded.

Figure 49 Wheelchair and Loading Parcels on Crosswalk (Sheth, 2017-2018)

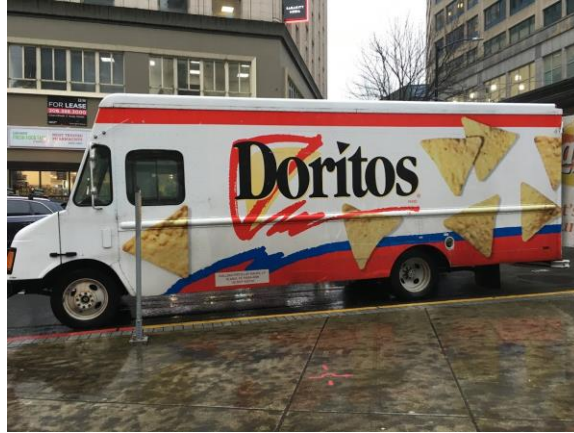
The vehicle observed was a Frito-Lay company vehicle. This is a Class 5 vehicle. There is no driver side door. Only a passenger door which slides open. The cargo compartment is located at the back end of the vehicle and has two open out doors. Figure 50 exemplifies the truck type and design. Note that there are no doors on the driver’s side.

Figure 50 Observed Frito-Lay Vehicle Design (Sheth, 2017-2018)

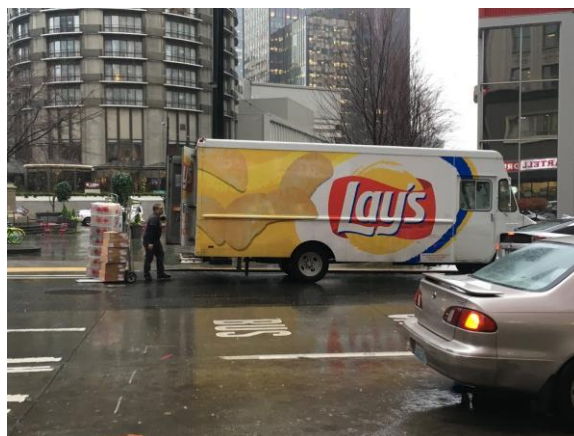
Two hand trucks were used to make this delivery. The hand trucks were loaded inside the cargo compartment, and then lifted and placed out onto the crosswalk. These hand trucks were carrying chips, so their total weight was not severe, despite the high volume being delivered. Figure 51 shows the hand trucks placed on the crosswalk. These hand trucks seem relatively light, even after being loaded because the courier driver made the delivery using two dollies at the same time. The courier driver then walks the items across the crosswalk to the other side.

Figure 51 Hand Trucks Loaded and Placed on Crosswalk (Sheth, 2017-2018)

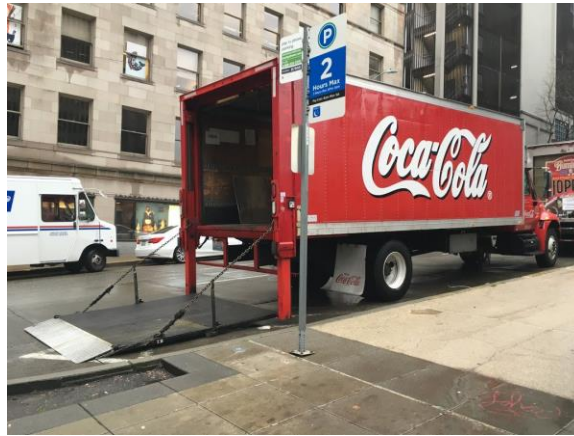
at the back end of the vehicle, and it has a roll up cargo door as well as a lift gate. Figure 52 exemplifies the observed vehicle and its design elements.

Figure 52 Observed Coca-Cola Vehicle Design Elements (Sheth, 2017-2018)

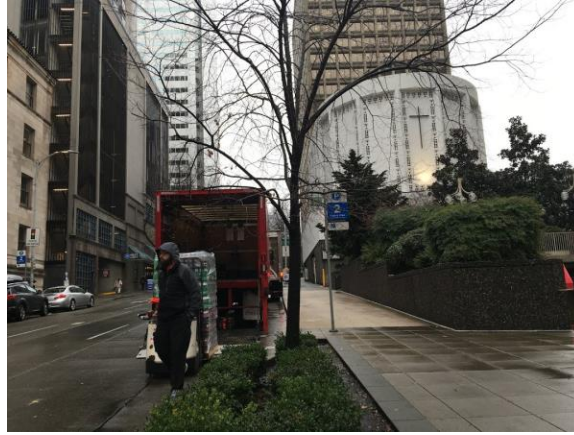
A pallet jack was used for this delivery. At the time of the observation, the pallet jack was already loaded inside the cargo compartment and was coming down to the lift gate, as seen in Figure 53. After the nearest crosswalk gave the pedestrian signal, the courier driver walked with the pallet jack over to the crosswalk and onto the parallel curb. This action is exhibited in Figure 54. After the delivery is completed, the pallet jack is brought to the lift gate, and returned to the cargo compartment.

Figure 53 Courier Exiting Cargo Compartment with Loaded Forklift (Sheth, 2017-2018)

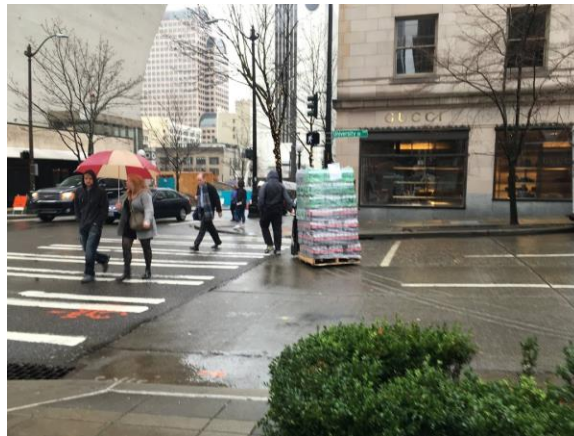
Figure 54 Courier Street Crossing with Forklift (Sheth, 2017-2018)

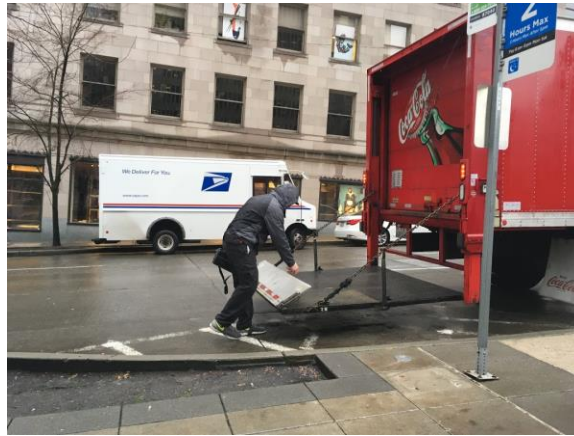
Figure 55 Portion of Lift Gate Manually Folded (Sheth, 2017-2018)

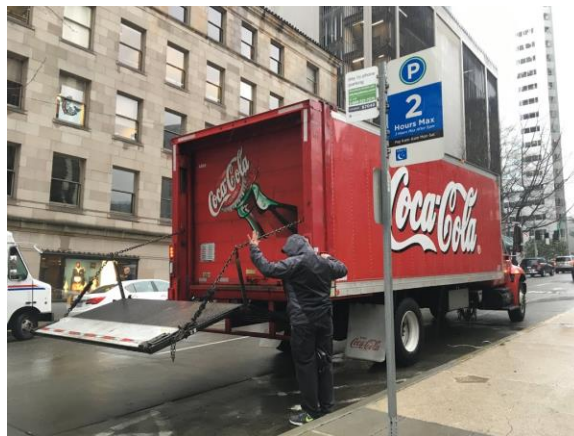
He then stepped off of the lift gate, further behind it in order to fold one segment of the lift gate in. The folding of the silver part of the lift gate can be seen in Figure 55. In order to disengage the lift gate, the courier driver stood on the right side of the lift gate on the road, in between the lift gate and sidewalk. He pushed a button and guided the lift gate to disengage and collapse into

a solid structure that rests on the back end of the truck. An image of the courier driver guiding the lift gate shut can be seen in Figure 56.

Figure 56 Courier Guiding Lift Gate Shut (Sheth, 2017-2018)

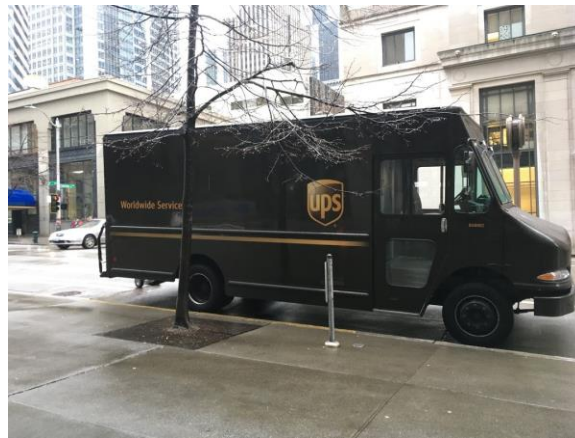
This vehicle type has sliding driver and passenger doors and a lift up and roll up cargo compartment at the back end of the vehicle. Figure 57 exemplifies the design elements of the observed vehicle.

Figure 57 Observed UPS Vehicle Design (Sheth, 2017-2018)
