Observing Goods Delivery Activities and Identifying Opportunities to Improve the Design of Commercial Vehicle Load Zones in Seattle

A thesis

submitted in partial fulfillment of the
requirements for the degree of
Master of Urban Planning
University of Washington
2018

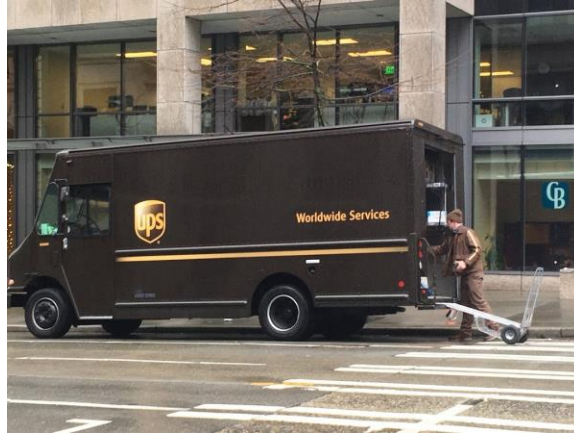
At the time of the observation, a hand truck was used to manage returned parcels. The hand truck rested at an angle against the vehicle from the roadway, as seen in Figure 58. After the parcels are unloaded and placed in the cargo compartment, the hand truck is straightened up and placed behind the cargo compartment on the road during the next 30 minutes of the observation.

Figure 58 Hand truck Resting at Angle on UPS Vehicle (Sheth, 2017-2018)

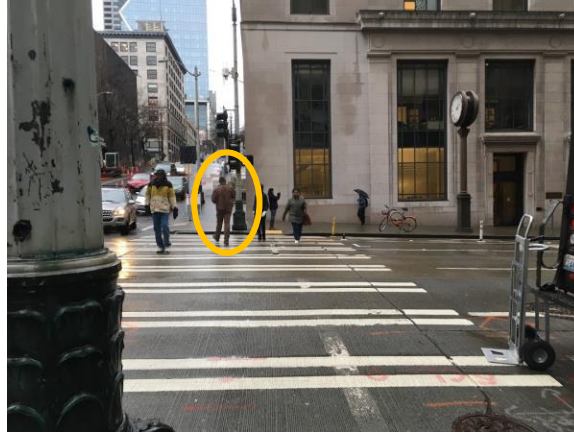
At the time of the observation, the delivery had already started. The courier driver and courier were observed standing on the road next to the cargo compartment organizing parcels and preparing for the next hand delivery. They then dispersed either across the street using the crosswalk over to the other side, or the sidewalk adjacent to the parked vehicle to complete deliveries. Figure 59 shows the courier making a hand delivery using the crosswalk and the empty hand truck left on the street behind the vehicle's cargo compartment. The courier was observed finishing his delivery earlier than the courier driver, and he waited for his colleague in the passenger seat.

Figure 59 Courier Using Crosswalk & Stagnant Hand truck (Sheth, 2017-2018)

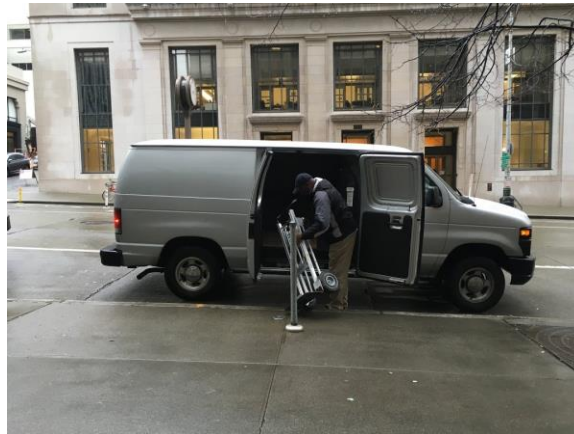
This vehicle has a driver, passenger, back end cargo, and passenger side cargo doors, all of which are swing out doors. The van's design elements can be seen in Figure 60.

Figure 60 Observed Delivery Van Design (Sheth, 2017-2018)

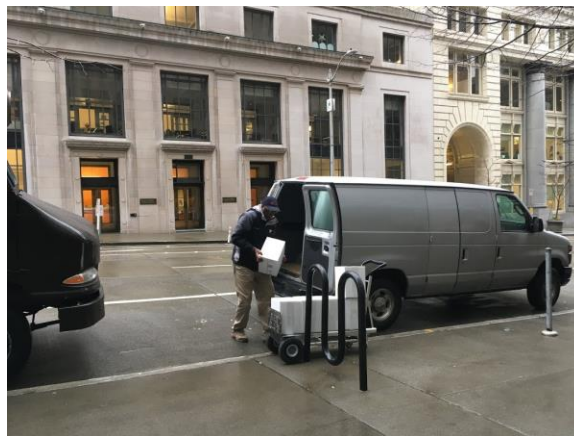
moved to the cargo compartment on the back end of the vehicle. Here, he stood directly next to the cargo compartment on the road in order to unload the cargo compartment behind the vehicle and place items on the hand truck, which was perched on the sidewalk next to him. Figure 61 depicted this action. This was a failed delivery. When the courier driver returned with the failed delivery, he stayed on the sidewalk and loaded the passenger cargo compartment from the sidewalk. After the delivery was completed, he walked around the back end of the vehicle to the driver side.

Figure 61 Courier Observed Loading 2- way hand truck (Sheth, 2017-2018)

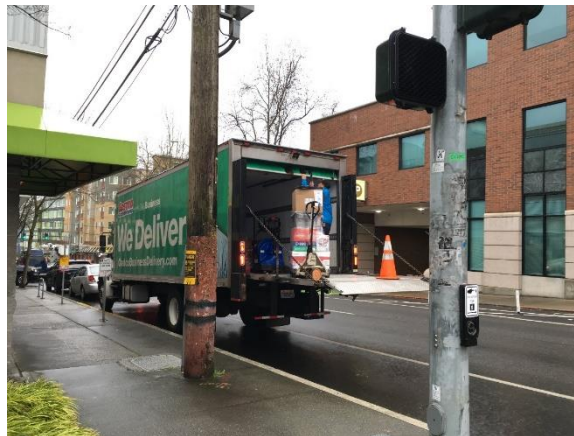
Figure 62 Observed Costco Delivery Vehicle (Sheth, 2017-2018)

The observed vehicle is a Costco vehicle. This is a Class 5 vehicle. The driver and passenger doors are both swing out doors. The cargo compartment is located at the back end of the truck, and has a roll up cargo door as well as a lift gate. Figure 62 exemplifies the design of the truck with the lift gate extended.

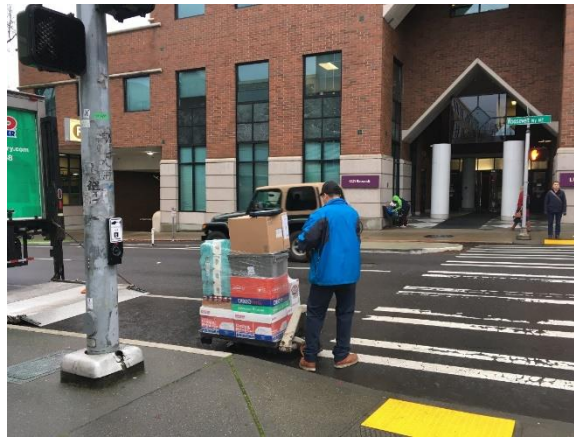
Figure 63 Courier Waiting for Crosswalk Signal in Passenger Load/Unload Zone (Sheth, 2017-2018)

In the observed delivery, a pallet jack was used to transport the goods. The items were organized onto the pallet jack in the cargo compartment. Then was taken on the lift gate down to the road. The pallet jack stayed behind the vehicle on the road, until the courier driver was signaled to

cross. Figure 63 exemplifies the pallet jack on the road. This portion of the roadway is designated for passenger load/unload zone, and is demarcated by the white paint on the curb. After the delivery was completed, the pallet jack was brought back to the lift gate and returned to the cargo compartment.

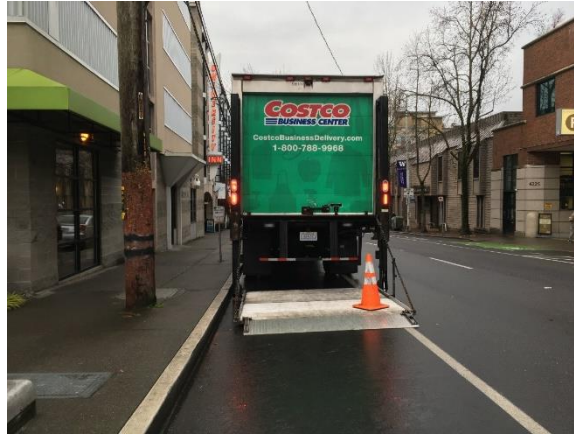
Figure 64 Extended Lift Gate with Cone (Sheth, 2017-2018)

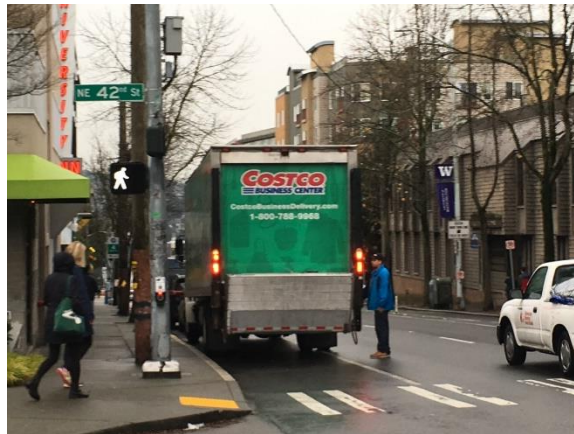
Figure 65 Courier Operating Lift Gate - Standing in Transit Lane (Sheth, 2017-2018)

cargo compartment. He then takes the lift down, and steps into the adjacent transit lane in order to access the button that collapses the lift gate. Figure 65 shows the courier driver standing in the roadway to operate the lift gate. Note the oncoming white vehicle next to him.

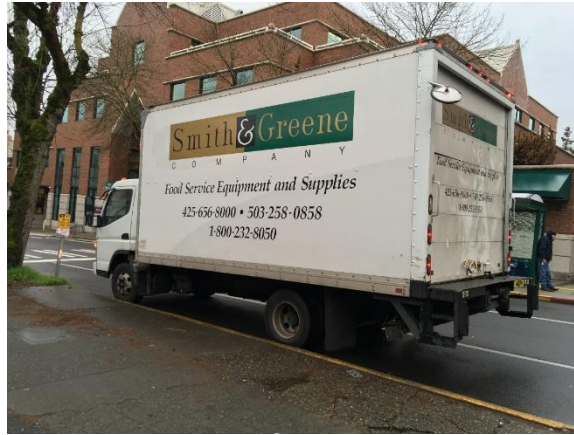
Figure 66 Observed Smith & Greene Vehicle (Sheth, 2017-2018)

The observed delivery involved is a Smith & Greene company vehicle. Smith & Greene is a food service equipment and supplies store. This vehicle is a Class 5 truck. The driver and passenger doors are both swing out doors. The cargo compartment is located at the back end of the truck, and has a lift up cargo door. Figure 66 exemplifies the vehicle type and design.

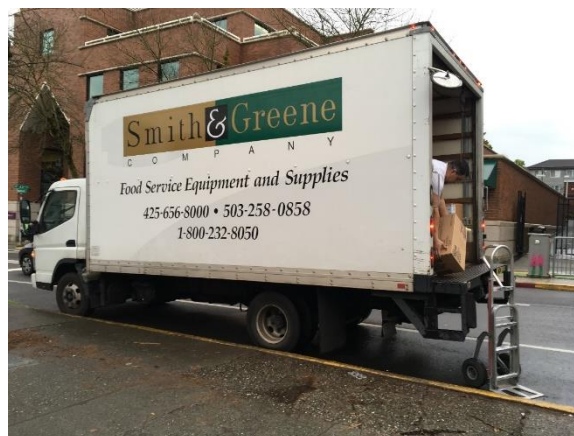
Figure 67 Hand Truck Placed Behind Cargo Compartment (Sheth, 2017-2018)

A hand truck is used in this delivery. It is removed from the cargo compartment, assembled, and placed behind the cargo compartment. Figure 67 depicts the hand truck resting on the road, waiting to be loaded. After the hand truck is loaded, the courier driver lifts it over the curb and makes the delivery. Upon completing the delivery, the courier driver returns, collapses the hand truck, and places it back in the cargo compartment.

This vehicle is parked at a CVLZ on a one-way street with two transit lanes adjacent to the parking lane, and a protected bike lane in the third lane over from the parked vehicle. The length of the CVLZ accommodates this vehicle, and the extended use behind the cargo compartment. There is a solid white lane present to demarcate the width of the CVLZ, which also accommodated the width of this vehicle. The courier driver was observed comfortably loading his hand truck behind the cargo compartment.

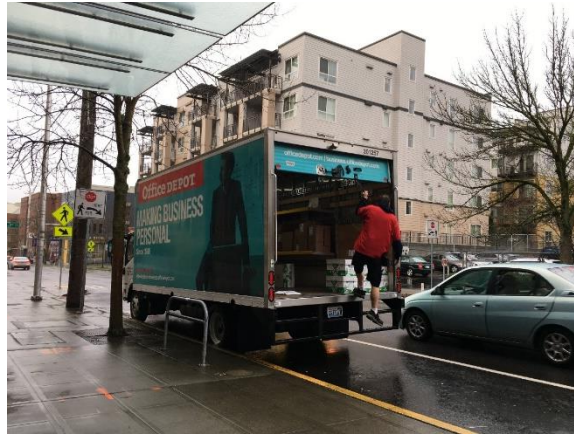
Figure 68 Observed Office Depot Vehicle (Sheth, 2017-2018)

The observed delivery involved is an Office Depot vehicle. This vehicle is a Class 5 truck. The driver and passenger doors are both swing out doors. The cargo compartment is located at the back end of the truck, and has a roll up cargo door. Figure 68 exemplifies the vehicle type and design.

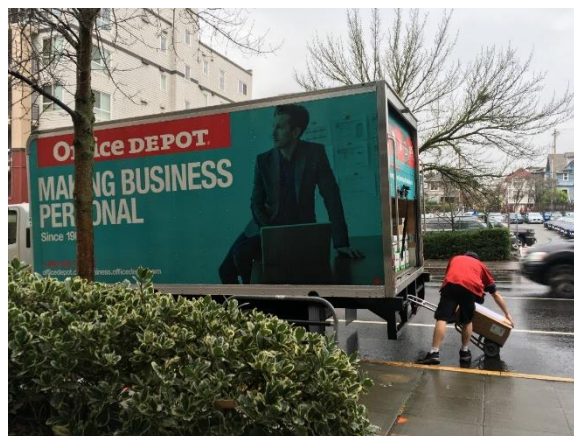
Figure 69 Tilted Handtruck Loaded (Sheth, 2017-2018)

A hand truck was used in this delivery. The hand truck was stored in the cargo compartment, but taken out and placed on the road behind the cargo compartment. Here, the hand truck was tilted against the vehicle and loaded. After the hand truck was loaded, the courier driver lifted the hand truck over the curb. Upon the delivery being completed, the hand truck was rolled over to the road space behind the cargo compartment and placed in the cargo compartment.

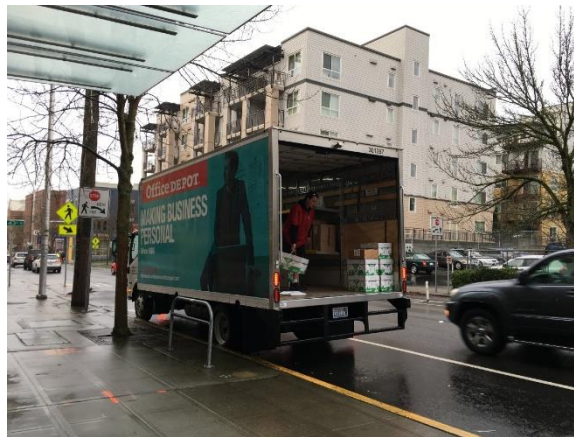
Figure 70 Driver/Courier Organizing Parcels in Cargo Compartment (Sheth, 2017-2018)

The courier driver exited the driver's side of the vehicle, lifted the cargo door, and stepped inside to organize parcels. Figure 69 exemplifies the courier driver organizing the parcels inside the cargo compartment. He then places the hand truck on the roadway and stepped into the road next to the hand truck to load parcels from the cargo compartment onto the hand truck. After the hand truck is loaded, he closes the cargo compartment, and walks the hand truck up and over the adjacent sidewalk. He completes his delivery and returns to the vehicle with returned parcels. He loads the cargo compartment with the returned parcels while standing on the road behind the cargo compartment. He places the hand truck inside and walks to the driver's seat using the sidewalk.

accommodated the width of this vehicle. The courier driver was observed comfortably loading his hand truck behind the cargo compartment.

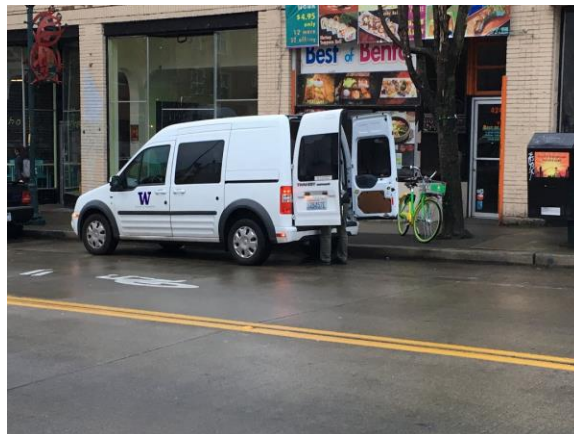
Figure 71 UW Van Delivery (Sheth, 2017-2018)

The observed delivery involved is a University of Washington commercial vehicle. This vehicle is a Class 3 vehicle. The driver and passenger doors are both swing out doors. The secondary driver and passenger doors are slide open doors. The cargo compartment is located at the back end of the truck, and has two swing out doors. Figure 71 exemplifies the vehicle type and design.

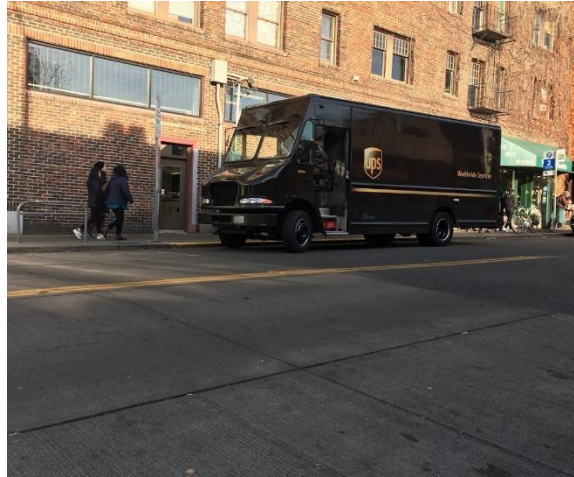
Figure 72 UPS Delivery Vehicle Type Observed (Sheth, 2017-2018)

A UPS delivery truck was observed during this delivery. This is a Class 5 vehicle. This vehicle type has sliding driver and passenger doors and a roll up cargo compartment at the back end of the vehicle. Figure 72 exemplifies the design elements of the observed vehicle. Note that this image is not of the actual location of observation.

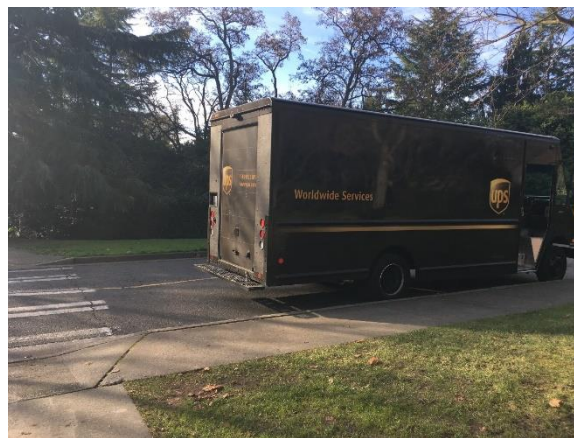
Figure 73 UPS Vehicle Type Observed (Sheth, 2017-2018)

A UPS delivery truck was observed during this delivery. This is a Class 5 vehicle. This vehicle type has sliding driver and passenger doors and a lift up and roll up cargo compartment at the back end of the vehicle. Figure 73 exemplifies the design elements of the observed vehicle. Note that this image is not of the actual location of observation.

For this delivery, one UPS employee was both the courier and driver. At the time of observation, the courier driver was in the middle of making deliveries. He was standing in the cargo compartment sorting parcels. How he exited /entered the vehicle was not observed.
